# (CUSTOMER SERVICE) SERVICE BULLETIN

NO	EHP 137
DATE	2/19/02
PRODUCT: GT

GT wheel hubs may show excessive wear after extensive use.

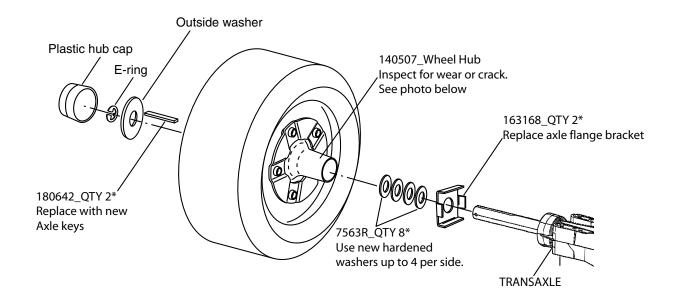
WORN HUB, BRACKET & WASHER

**CRACKED HUB**

ON SPECIFIC AUTOMATIC TRANSAXLE UNITS, THE KEYWAY INSIDE THE WHEEL HUB MAY BECOME DAMAGED DUE TO AN UNDERSIZED 2" KEY AND SOFT WASHERS. THERE MAY BE WEAR ON THE INSIDE SURFACE OF THE REAR WHEEL HUB, WASHERS AND AXLE FLANGE BRACKETS INBOARD OF THE GT WHEEL HUB. THIS CONDITION MAY DEVELOP AFTER SEVERAL HUNDRED HOURS OF EXTREME USE.

# \*THESE PARTS ARE INCLUDED IN KIT#180696

REMOVE THE TWO PLASTIC AXLE CAPS IF EQUIPPED, E-RINGS, AND OUTSIDE WASHERS AT THE END OF THE TRANSAXLE SHAFTS. REMOVE THE REAR WHEEL HUB ASSEMBLY, WASHERS/SPACER, THE 2" KEYS ON BOTH AXLES, AND THE TWO AXLE FLANGE WASHERS ADJACENT TO TRANSAXLE. INSTALL KIT# 180696 IN THE ORDER ILLUSTRATED. INSPECT THE WHEEL HUB FOR ANY CRACKS OR WEAR. IF THE WHEEL HUB IS CRACKED OR SHOWS EXTENSIVE WEAR REPLACE WITH PART # 140507. WHEN INSTALLING THE AXLE FLANGE WASHER, THE WIDER FLANGES GO ON TOP AND BOTTOM OF TRANSAXLE AS ANTI-ROTATIONAL FEATURES. REINSTALL ORIGINAL TWO E-RINGS, OUTSIDE WASHERS AND PLASTIC HUB CAPS.

NOTE: DO NOT REUSE ORIGINAL 2" LONG KEY, OR ORIGINAL WASHER / SPACER.
