SERVICE KIT 753-0549

SP-129

Model TMO-3746606 -

Replacement Baffle

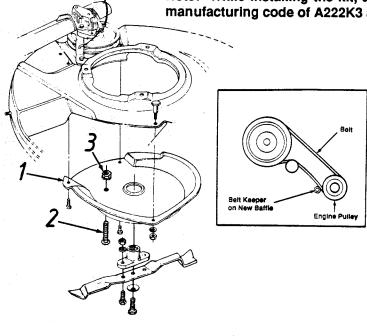
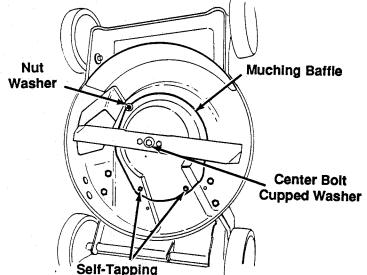
Reports from the field indicate that model TMO-3746606 self-propelled lawn mower with manufacturing codes from A142K3 thru A222K3, difficulty in pulling the unit backward has been encountered.

Install Service Kit 753-0549 which includes a revised mulching baffle with belt keeper attached.

- Remove the mulching baffle from the deck by removing two self-tapping screws, and the nut and washer.
 Temporarily place the nut on shoulder bolt to keep shoulder bolt in place. Discard old baffle.

- Remove the nut as you place the new mulching baffle in position, so that the belt is inside the belt keeper (phillips screw) as shown. Secure the mulching baffle using hardware just removed.
