Service Kit 753-0718

CODE: CP-025 DATE: December 3, 1997 SUBJ: Locking Rod for Log Splitters

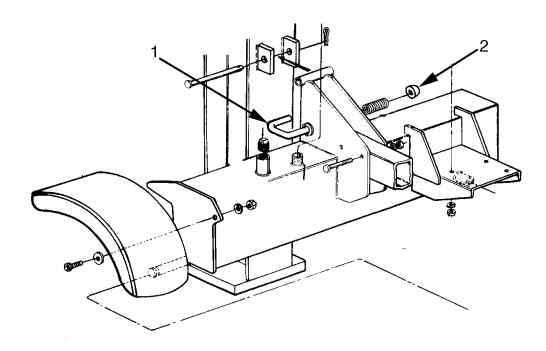
- **Problem:** Locking Rod (781-0370A) has been replaced with new locking Rod (781-0690)
- Cause: Locking Rod (781-0370A)
- Solution: Install Service Kit 753-0718

- 1. Remove the old Locking Rod (781-0370A) and hardware from the unit. Discard cotter pins because they will not be needed on new Locking Rod.
- 2. Install the new Locking Rod (**781-0690**) and replace the washers and the spring from the previous rod. Secure the Locking Rod with (**726-0214**) push cap supplied in the service kit. **See diagram below.**
